The Impact Of Walkways and Open Spaces on Promoting Sustainable Pattern of Life in the Campus Case Study Of Mahlia Girls' Campus Jazan University , Saudi Arabia Muna AHMED ^{a*}

ENGINEERING JOURNAL Volume 2 Issue 2

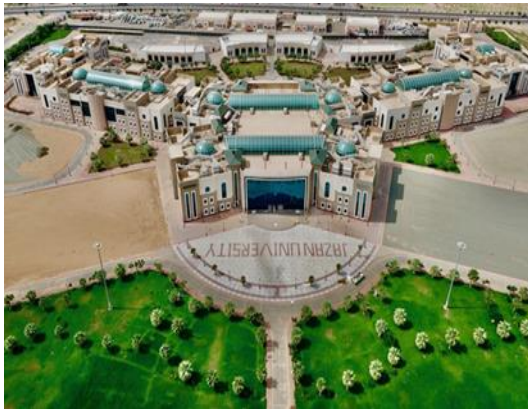
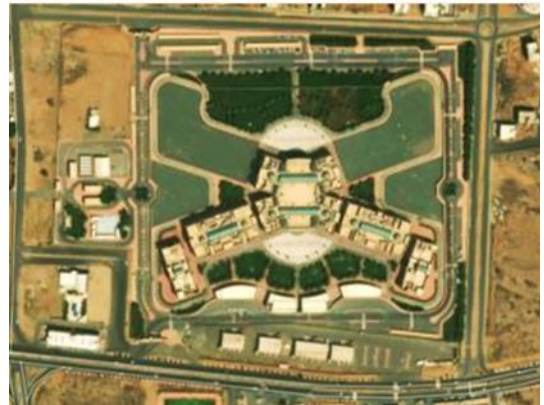
Fig. 1. Mahlia Girls Campus , Jazan University , Jazan , Saudi Arabia

The study was conducted among students at Mahlia female campus , it comprises 5 buildings, 350 lecture halls of various types , 60 laboratories serving the beneficiary colleges and a 500 seat theatre, as well as a central library , 400 Offices for academic staff members , gymnasium for sports and recreational activities, student service centres , a cafe complex and lounges. The total area of the campus is approximately 270000 square meters (450*600) with approximately eight thousands of students(8000) and (600) staffs .The campus has one main central building and (4) smaller blocks in a fan shape lay out. It can be considered as a well-planned, newly constructed buildings finished in 2020 . The campus has two surrounding fences separated by a buffer zone with high walls (2.5) meters to provide privacy for female users inside the inner courtyard of the the campus .The buffer zone contains parking area for staff and students and services buildings . (Fig. 1 Mahlia Girls campus, Jazan University , Jazan , Saudi Arabia).
